VVER 2013

Post-irradiation inspections on TVSA-T fuel assemblies at Temelín NPP

Martina Malá

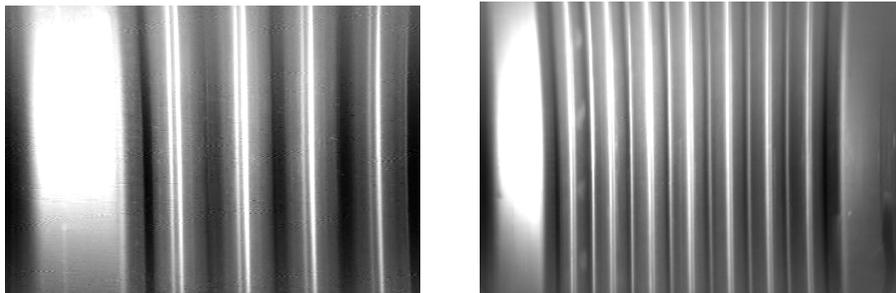
Fig. 1 Half-face (left) and full-face (right) visual inspection

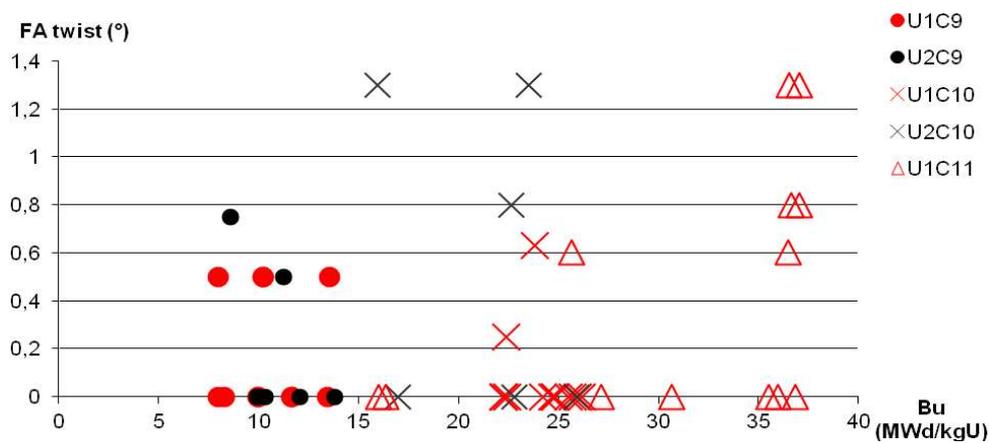
Fuel assembly twist after one, two and three cycles is negligible, as shown in Fig. 3. The assembly twist is independent on fuel burnup.

Fig. 3 Fuel assembly twist

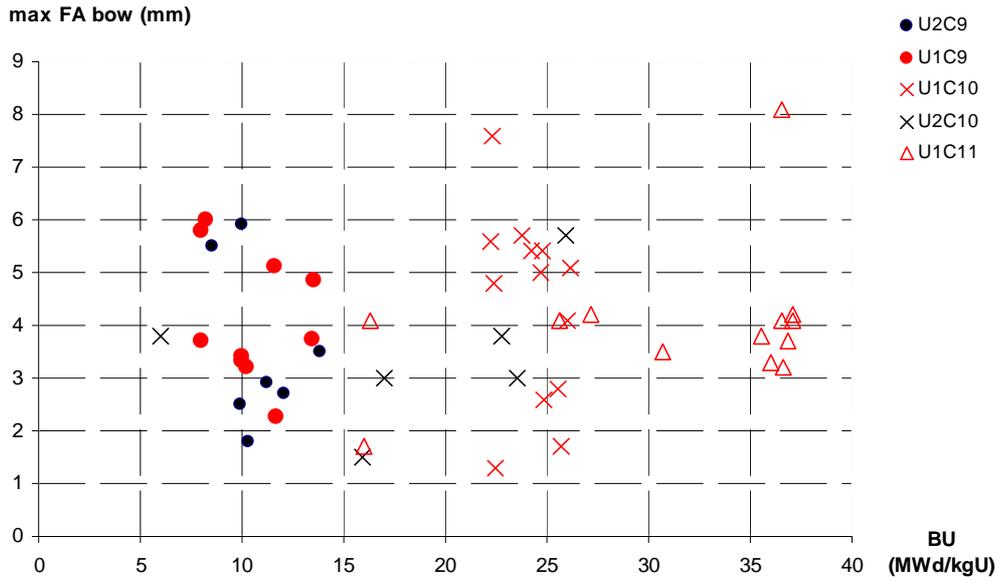
Fuel assembly bow meets the expectations and does not develop with burnup, as shown in Fig. 4. The maximal value is for the assemblies located mostly between the centre and the periphery of the core (see a red cross and a red triangle around 8 mm).

Fig. 4 Fuel assembly bow – maximal values

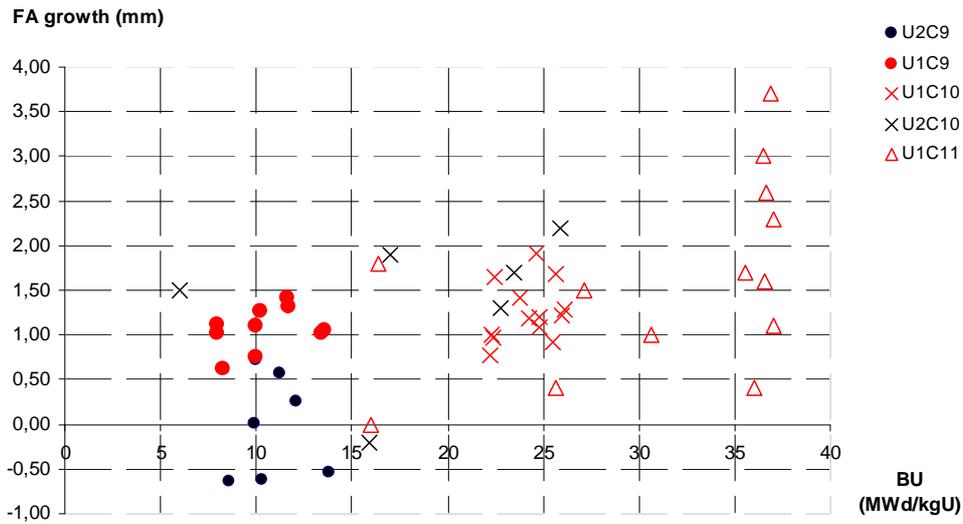
Fuel assembly growth seems to be affected by the position of upper core internals (BOT), see the negative values in Fig. 5.

Fig. 5 Fuel assembly growth

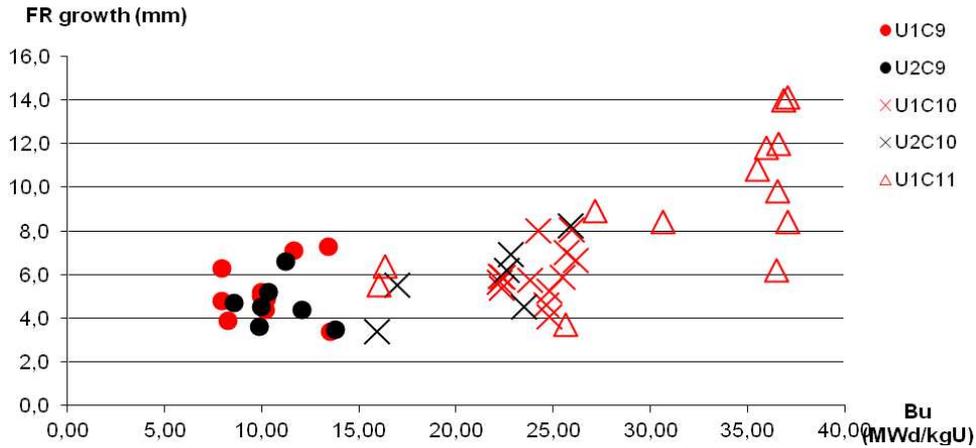
Fig. 6 Fuel rod growth

The growth of tvels (UO_2 fuel rod) develops with fuel burnup and is near the predicted value as mentioned above. The values of fuel rod growth are between 3 – 8 mm for one-year assemblies and up to 14 mm for three-year assemblies, see Fig. 6.

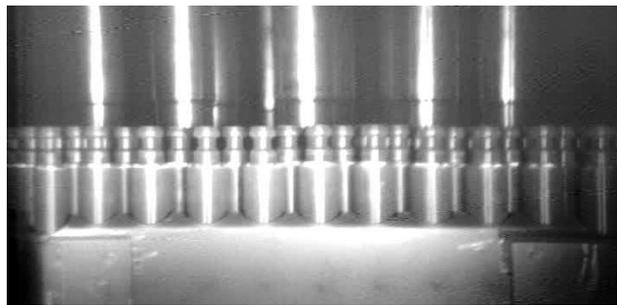
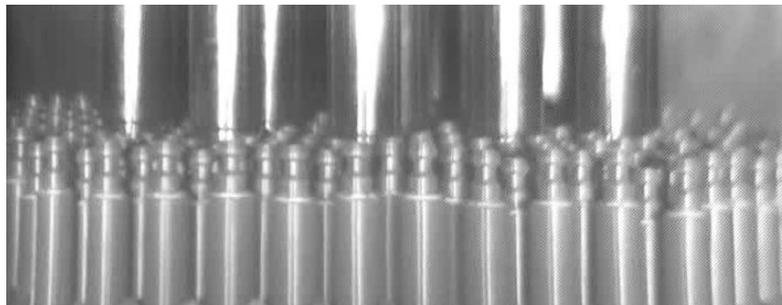
Fig. 7 Fuel rod growth after first cycle (up) and after third cycle (bottom)

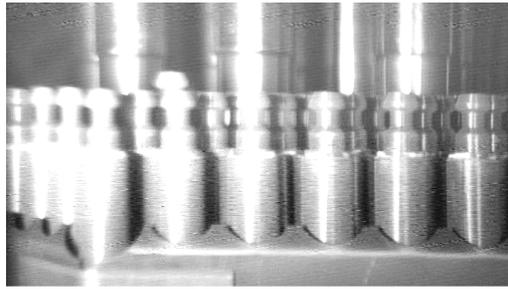
Values of growth of fuel rods with Gadolinium absorber (tvegs: $\text{UO}_2 + \text{Gd}_2\text{O}_3$) give small but noticeable difference between tvel and tveg growth observed already after 1st cycle at both units. It does not pose any safety or operational problem, but contradicted predictions. Such growth was observed only for some assemblies and only for some tvegs. So it is not a common behavior of all tvegs. The difference between tveg and tvel growth is shown in Fig. 8.

Fig. 8 Different growth of tveg and neighboring tvels

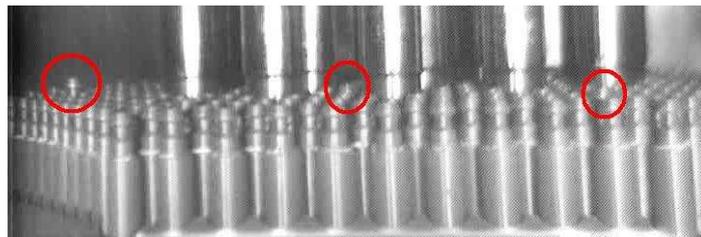
Such observed issue gave considered but dismissed possible causes: different tveg length from the manufacture, lower helium pressure under the cladding and faster cladding creep, different chemical composition or metallurgic properties of cladding tubes of certain batch, lower end-plug release from the fuel assembly support grid, pellet batch with higher content of hydrogen, or contamination of pellets or cladding tubes by organics leading to the hydriding of the cladding. The most probable reason is a difference in pellet-cladding contact moment between tvel and tveg. According to calculations the contact should occur slightly sooner in tveg, but not during the 1st cycle. After 1st cycle the growth could be caused if the fuel column is not fully centered.

Fig. 9 Three tvegs of higher growth than tvels identified on one face of fuel assembly

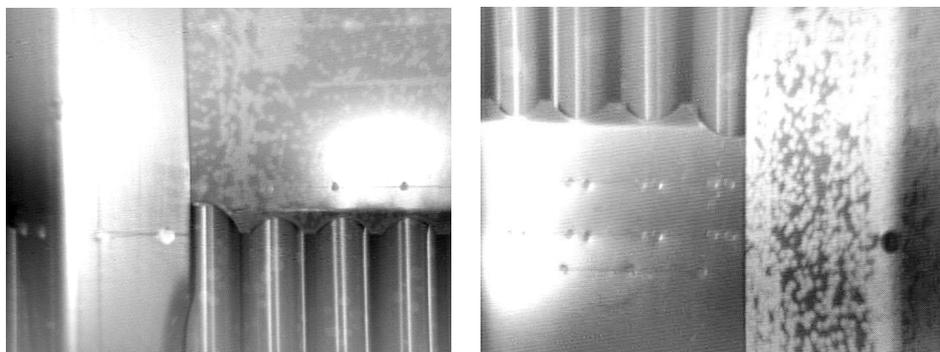
Visual examinations revealed very small amount of corrosion on the cladding and assembly skeleton surface, which was taken as a confirmation of good corrosion performance. The corrosion of fuel assembly surface meets the prediction and does not show any anomalies in the behavior. The corrosion depends on position and height in the core. Bigger corrosion is in the middle of the assembly where the active part of assembly is located. This behavior also shows a good condition of the primary circuit chemistry at both units of Temelín NPP.

Fig. 10 Corrosion situation after first cycle (left) and third cycle (right)
