Centrum výzkumu Řež s.r.o.

Post-irradiation inspections on TVSA-T fuel assemblies at Temelín NPP

VVER 2013

12.11.2013

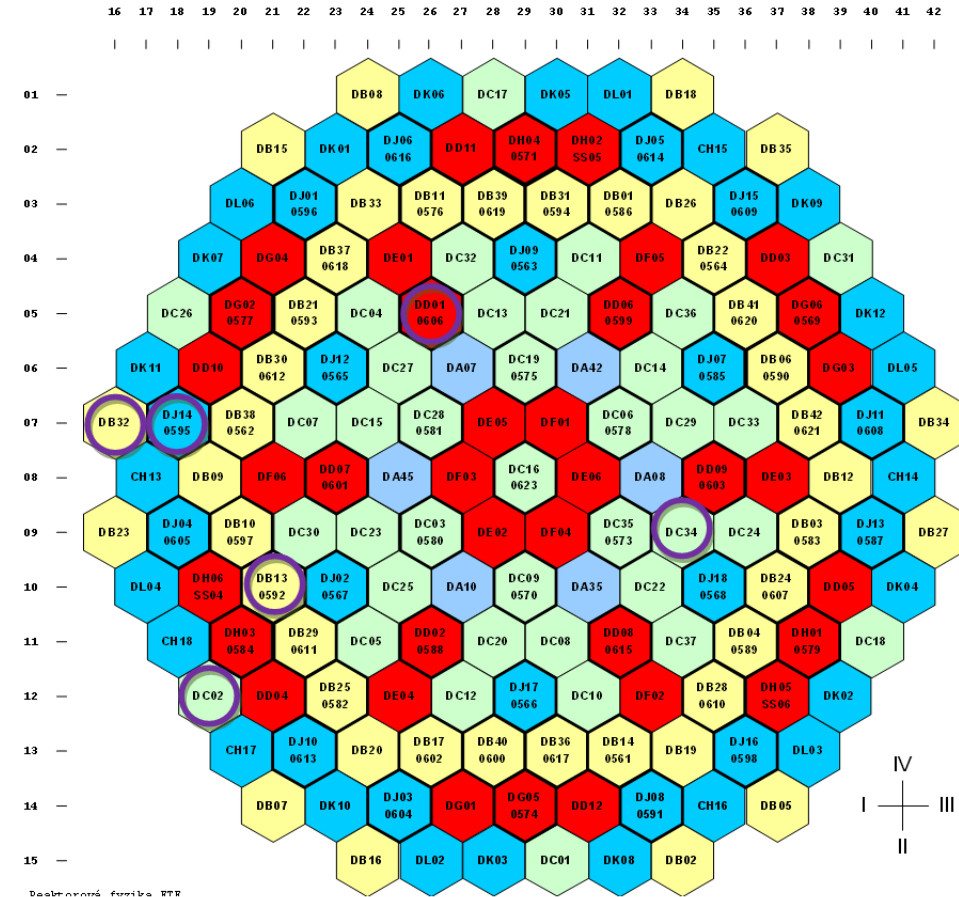
PIIP after U2C10

- Spring 2013
- after 2nd cycle with TVSA-T
- 1 one-year* and 5 two-year FAs
- BU: 15* – 25 MWd/kgU
- no leakers
- measurement of 6 FAs:
 - twist $\leq 1^\circ$
 - bow ≤ 5 mm (1 FA: 8 mm)
 - small difference of FA bow between U2C9 and U2C10
 - FA growth ≤ 2 mm
 - FR growth $\rightarrow 3 - 8$ mm

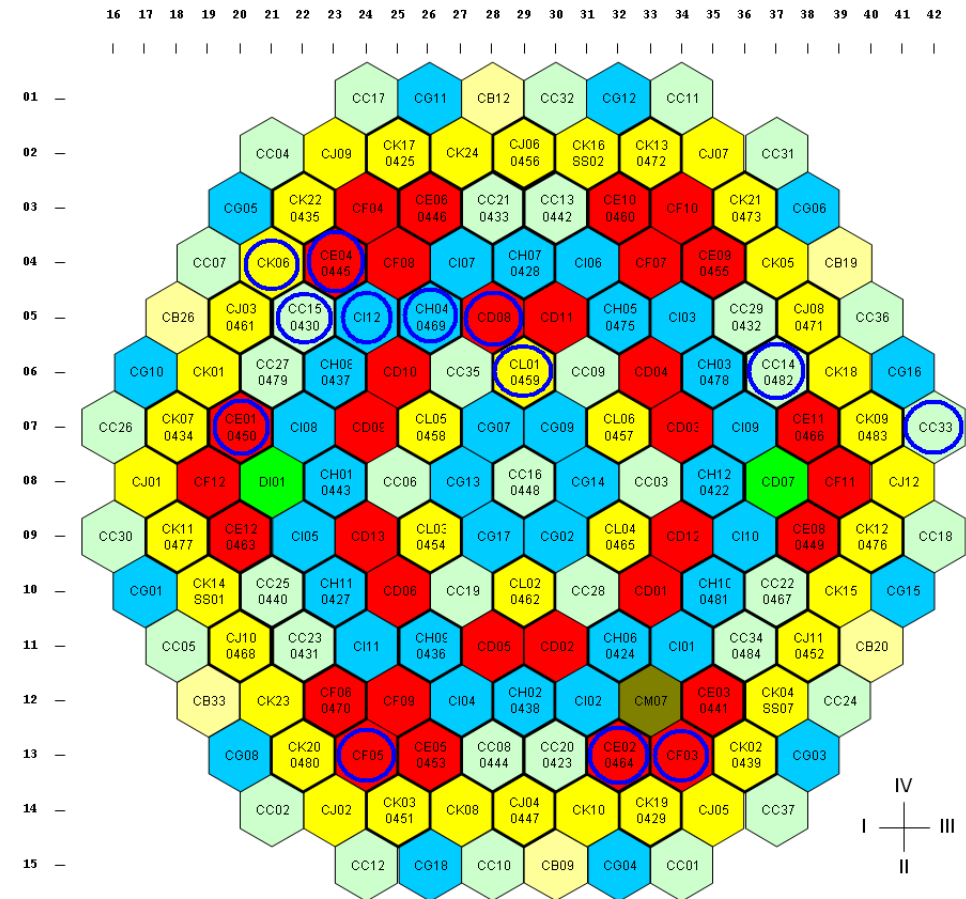
PIIP after U1C11

- July 2013
- after 3 cycles with TVSA-T
- BU: 16 – 37 MWd/kgU
- 9 three-year FAs, 2 two-year and 2 one-year FAs
- no leakers
- measurement of 13 FAs:
 - twist → immeasurable
 - bow ≤ 4 mm (1 FA: 8 mm)
 - small difference of FA bow between U1C9, U1C10 and U1C11
 - FA growth ≤ 3.5 mm
 - FR growth → 3 - 14 mm

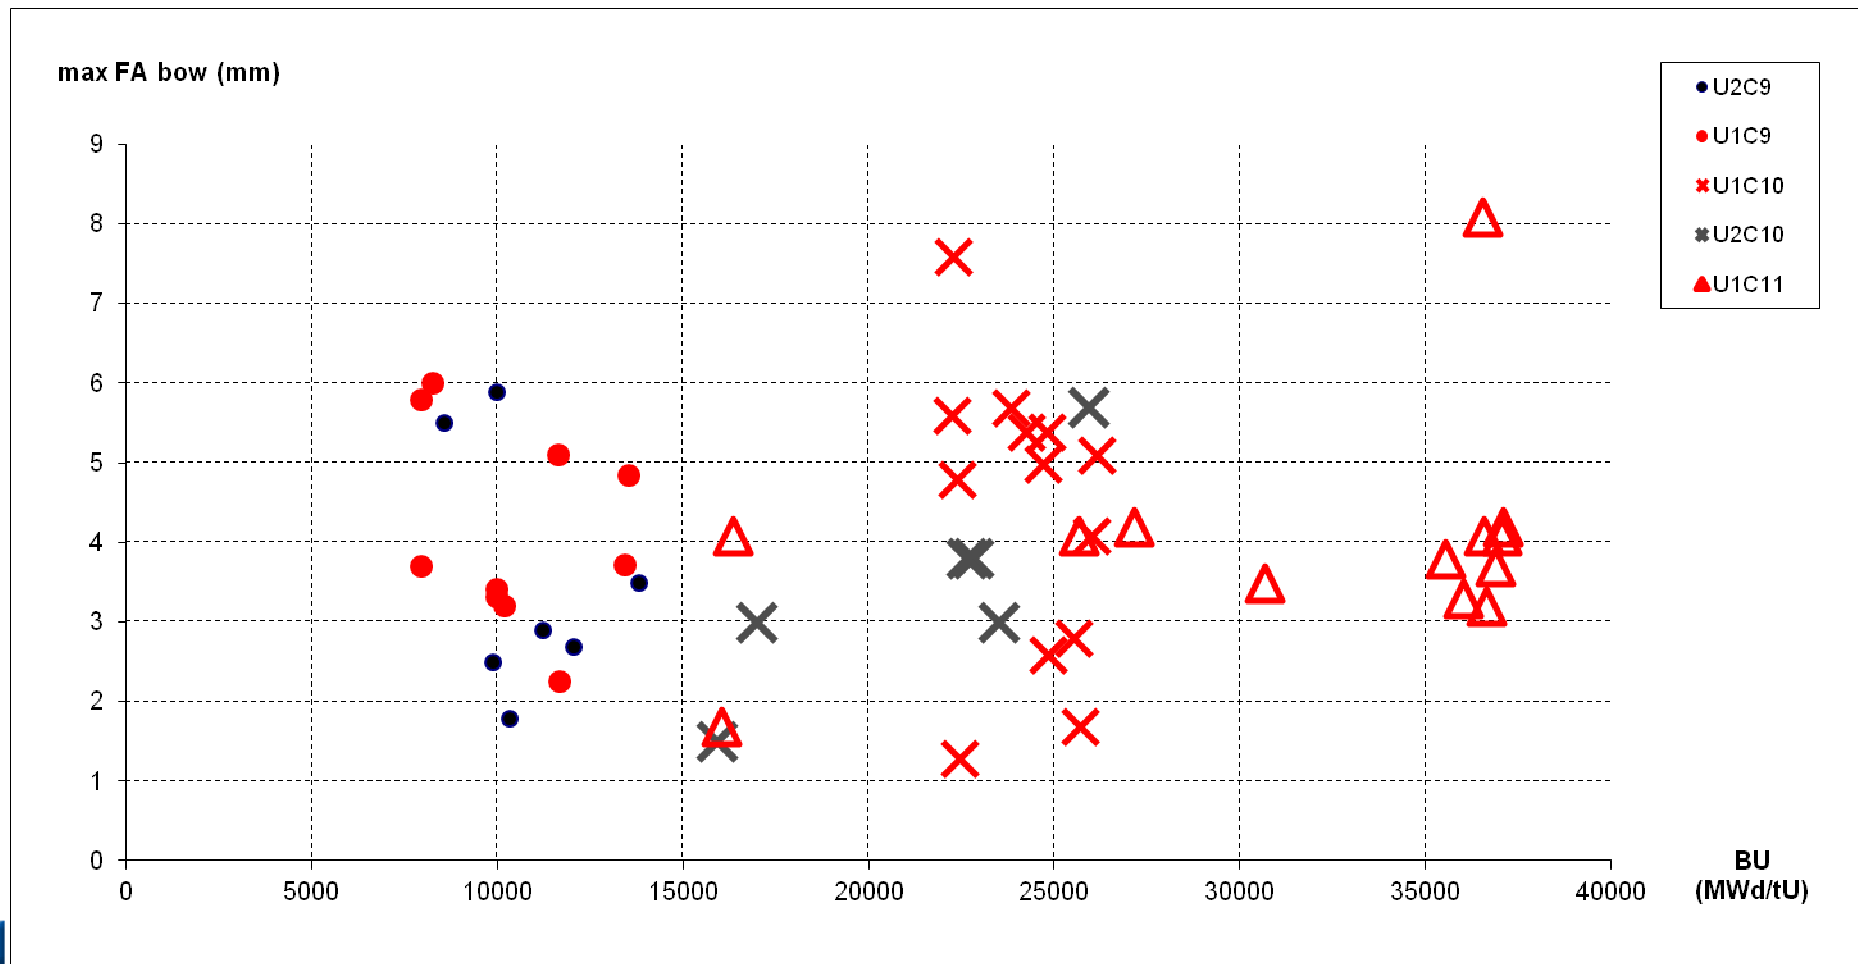
- FA bow meets the expectations and does not develop with burnup

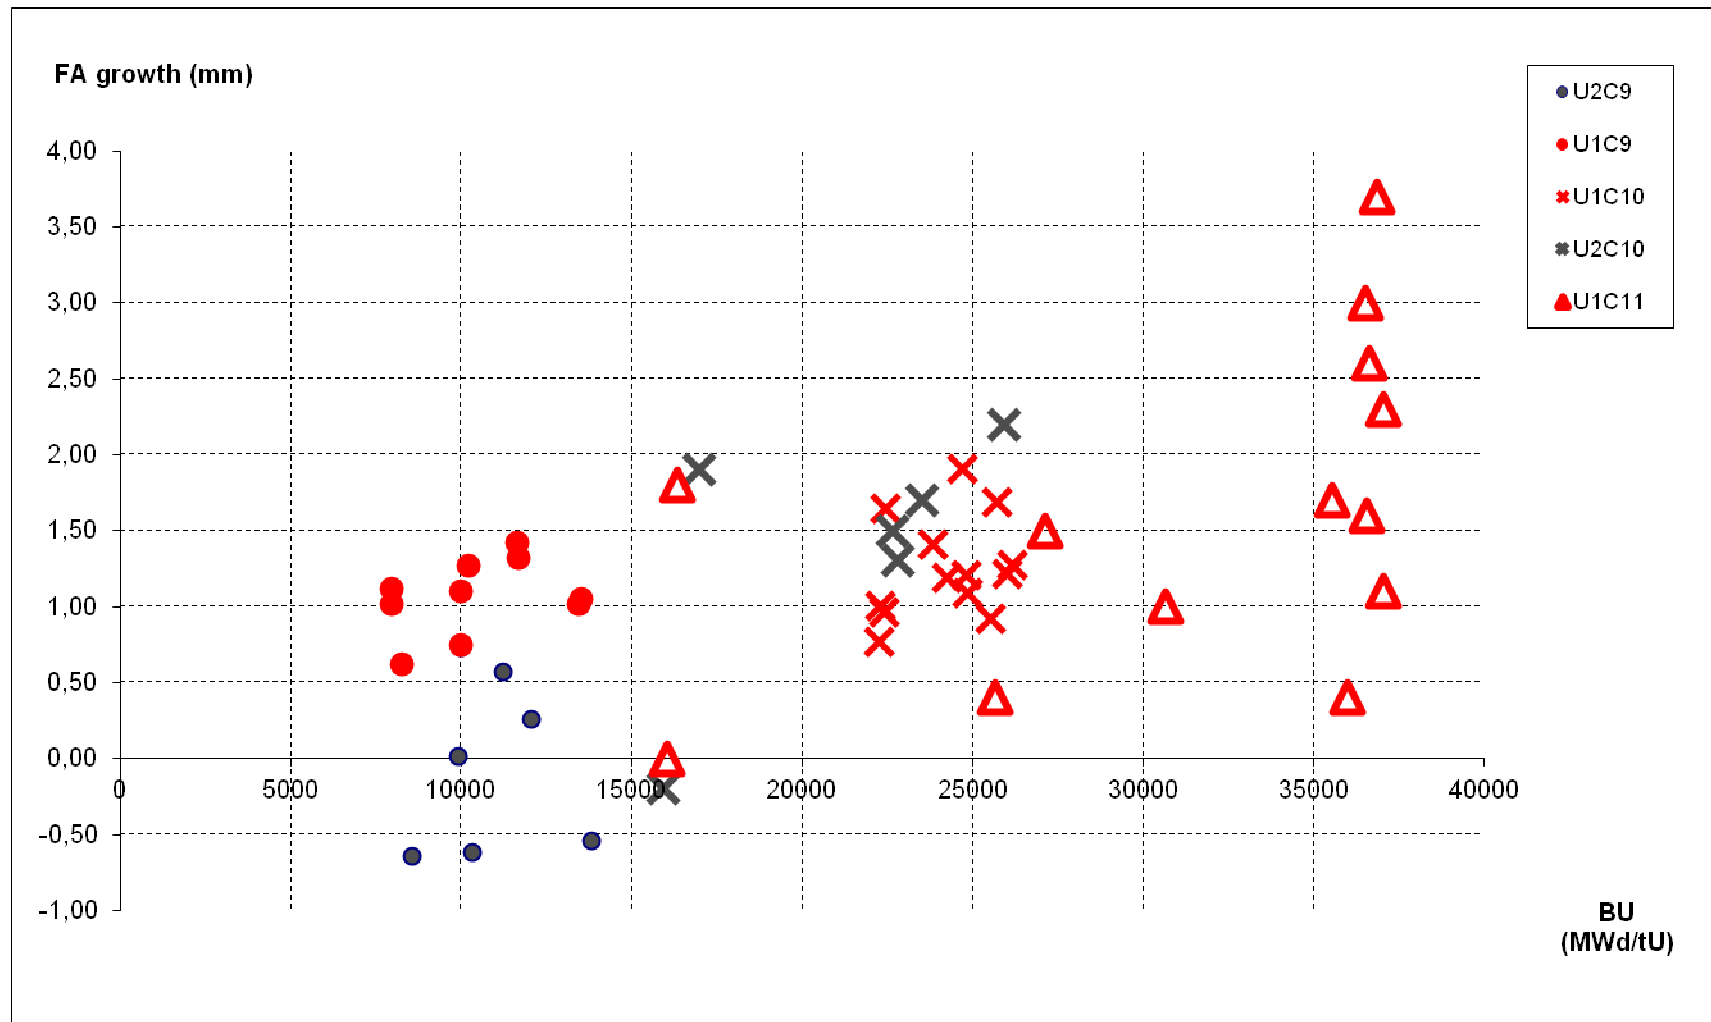
- FA growth seems to be affected by the position of upper core internals (BOT)

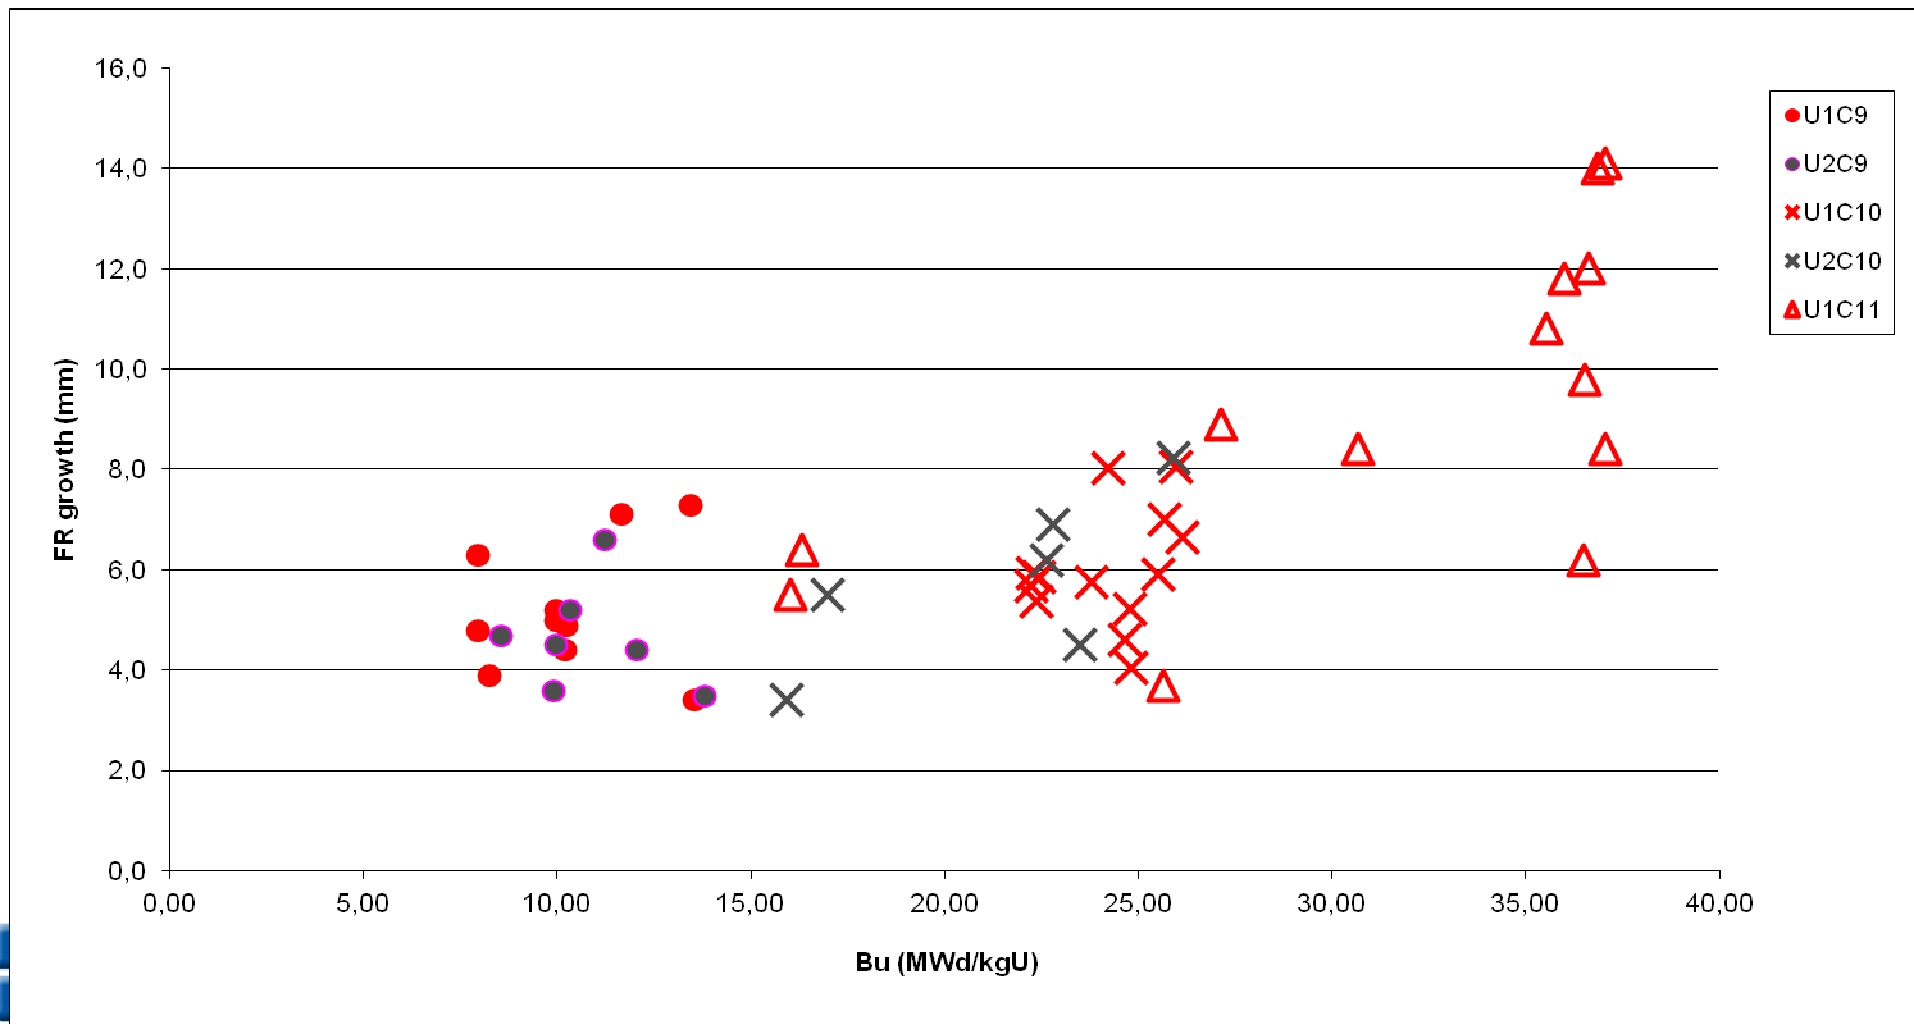
- FR growth is near the predicted value (0.1% / 10 MWd/kgU)
- Larger scatter after 3 cycles due to pellet-cladding contact

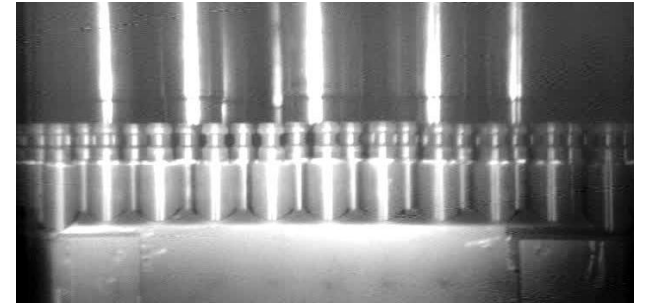
- **U1C9**

- 3 – 8 mm

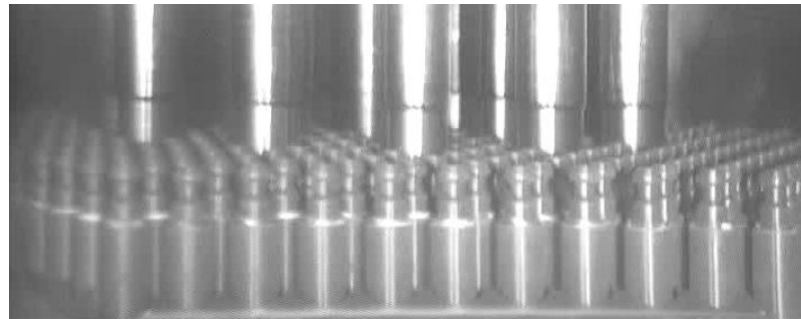
- **U2C9**

- 3.5 – 7 mm

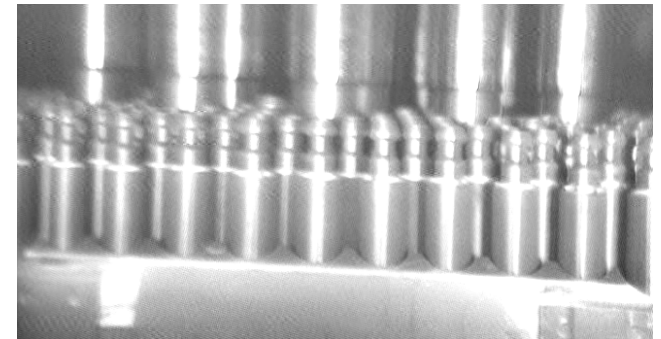
- **U1C10**

- 4 – 8 mm

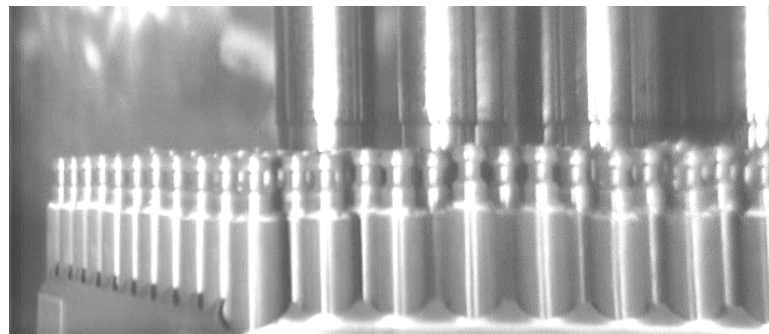
- **U2C10**

- 3 – 8 mm

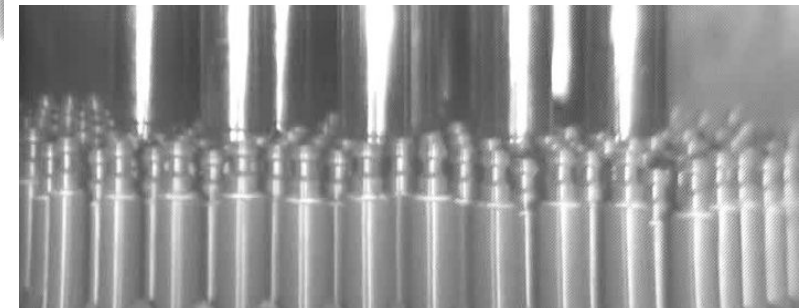
- **U1C11**

- 3.5 - 14 mm

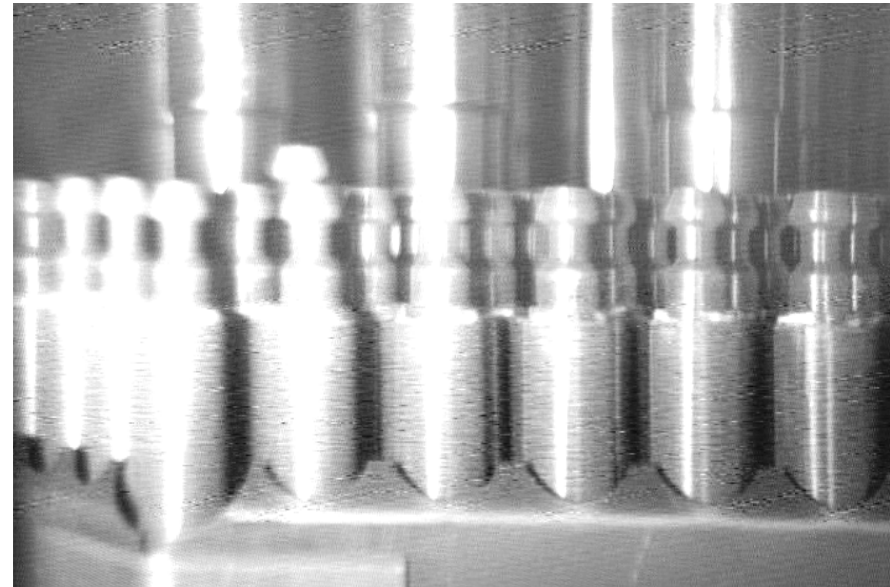
Fuel rod growth – tveg

- $\text{UO}_2 + \text{Gd}_2\text{O}_3$ rod
- small but noticeable difference between tvel and tveg growth observed already after 1st cycle at both units
- does not pose any safety or operational problem, but contradicted predictions
- observed only for some assemblies
- not common behavior of all tvegs

■ Discussion – considered but dismissed possible causes:

- different tveg length from the manufacture
- lower helium pressure under cladding and faster cladding creep
- different chemical composition or metalurgic properties of cladding tubes of certain batch
- lower end-plug release from the FA support grid
- pellet batch with higher content of hydrogen, or contamination of pellets or cladding tubes by organics leading to the hydriding of cladding

■ Most probable reason:

- Difference in pellet-clad contact moment between tvel and tveg
- According to calculations the the contact should occur slightly sooner in tveg, but not during the 1st cycle
- After 1st cycle the growth could be caused if the fuel column is not fully centered
