Centrum výzkumu Řež s.r.o.

Post-irradiation inspections on TVSA-T fuel assemblies at Temelín NPP

VVER 2013

12.11.2013

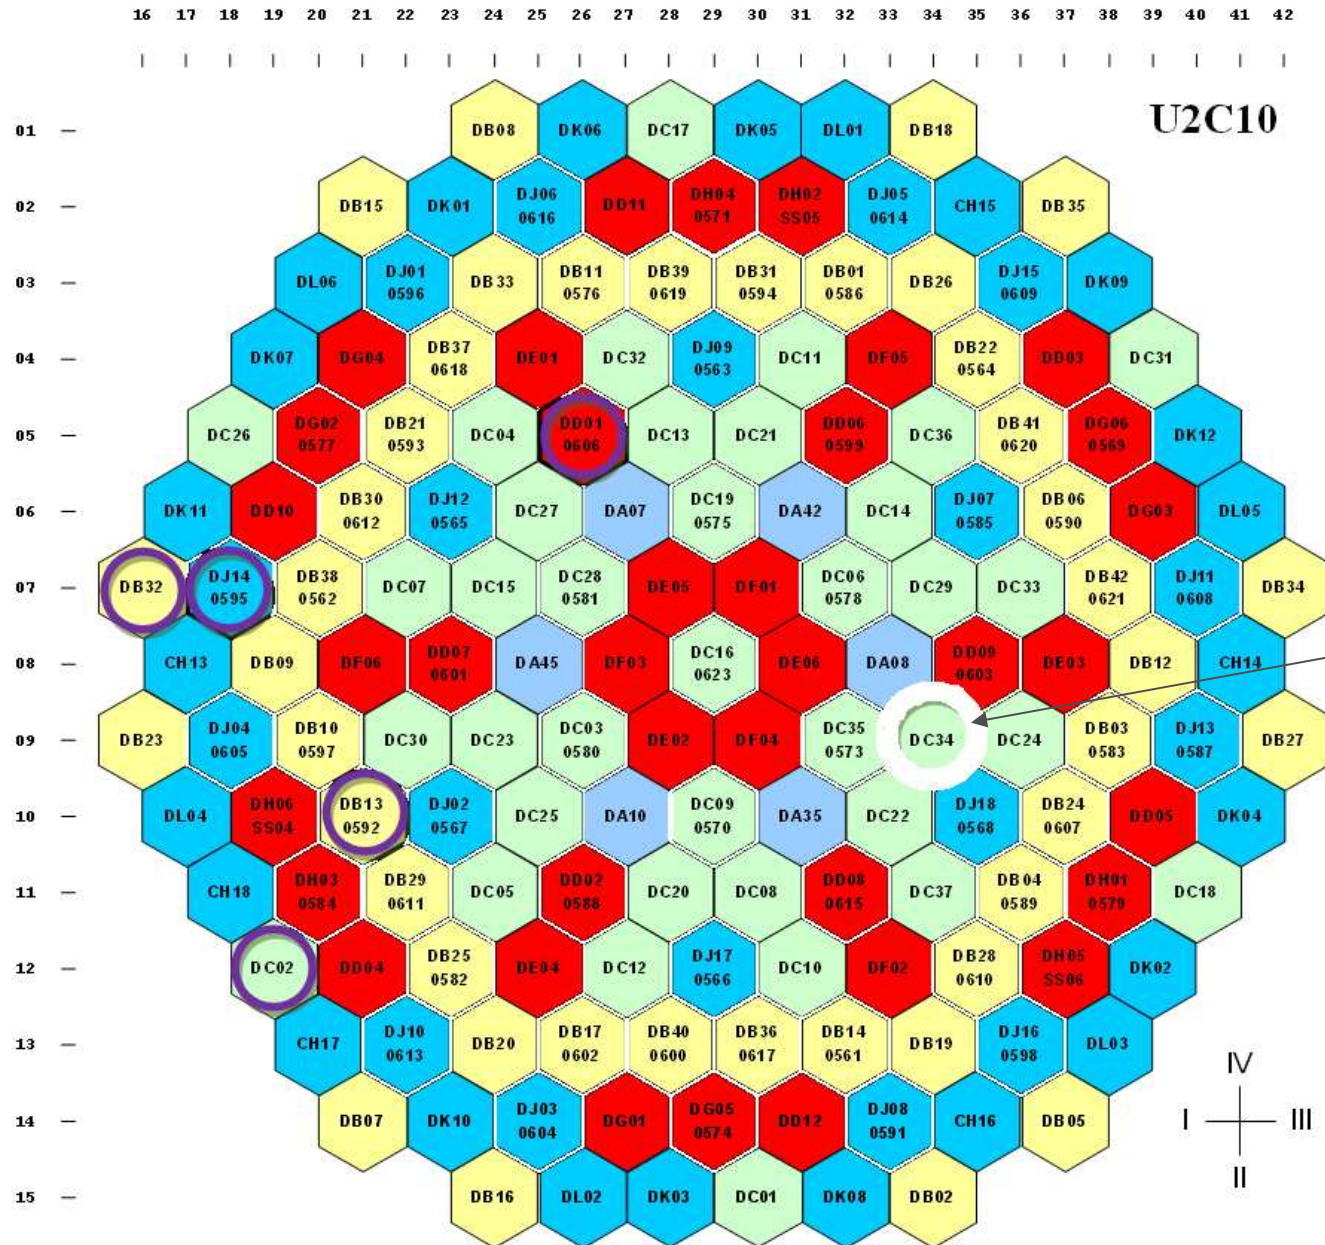
U2C10

- FA bow meets the expectations and does not develop with burnup

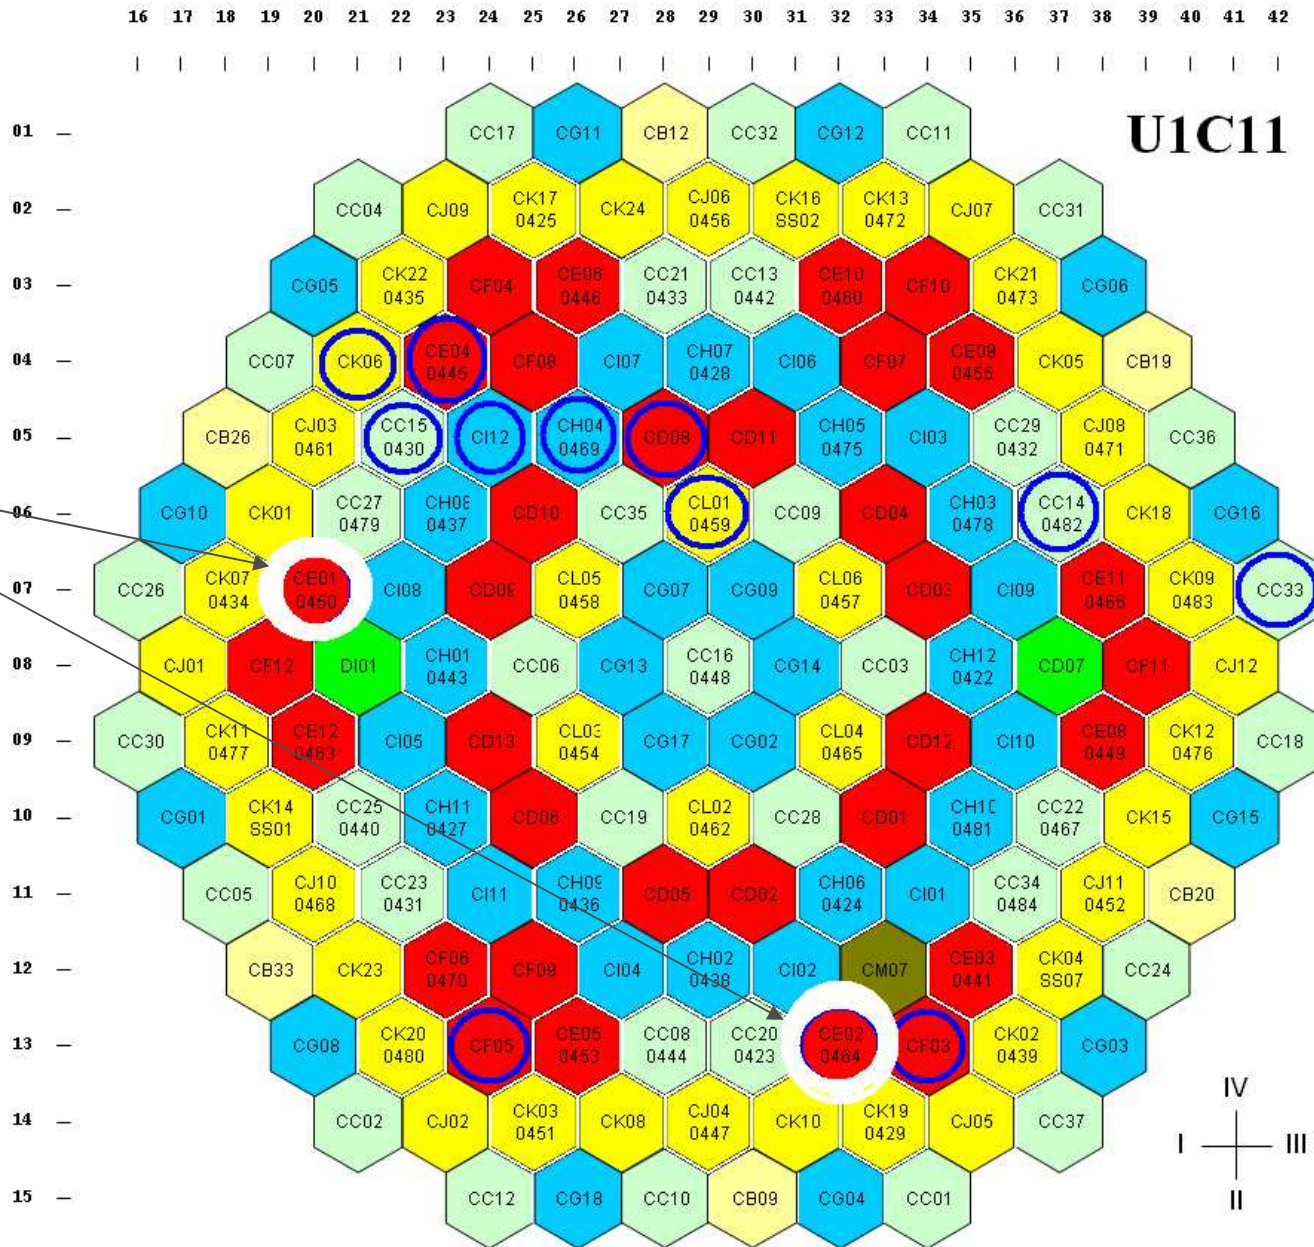
U1C11

- FR growth is near the predicted value (0.1% / 10 MWd/kgU)
- Larger scatter after 3 cycles due to pellet-cladding contact
